Town of Creston

Fire Hall

SUMMARY OF SITE ASSESSMENT

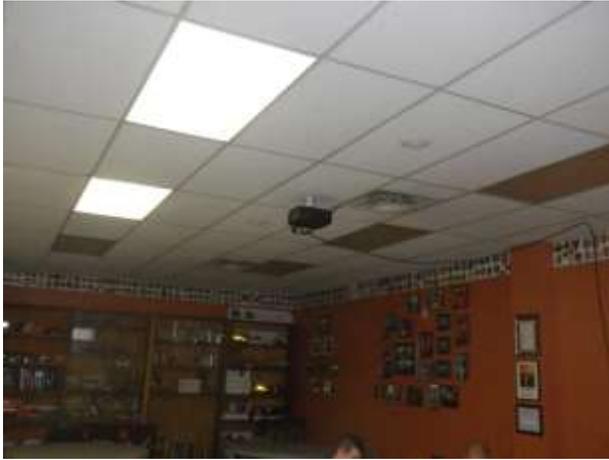
Duct Cleaning: All the make-up air vents supplying air to the training room, fire chief and deputy fire chief's offices were dirty. The return vent in the training room was also quite dirty which suggests the ducting throughout is dirty. Fine dusts will settle when the system is off and will reenter into the space when it reactivates. Any moisture entering the system will increase the risk of mould growth. Staff do not believe the ducting has been cleaned since it was installed. The entrainment of fine dusts can affect some people. Commercial ventilation systems should be cleaned at a minimum every 10 years.

Figure 1: Picture showing make-up air vents east side

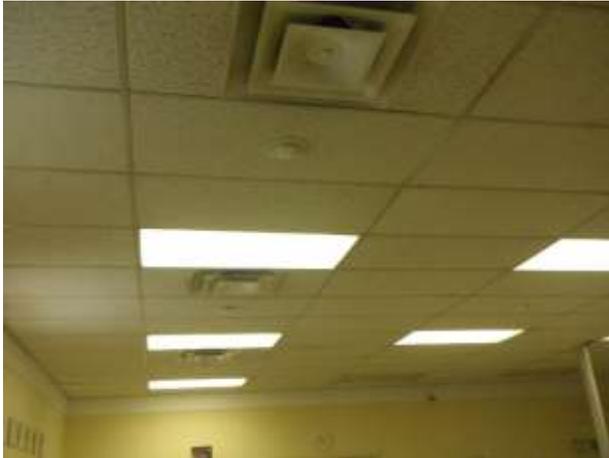
Figure 2: Picture showing make-up vents south side training room

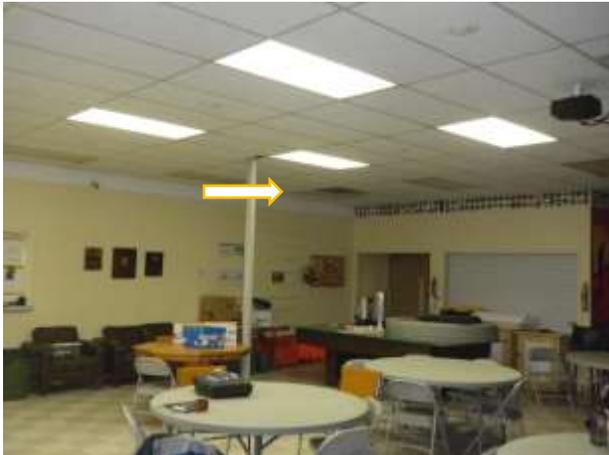
Return air: The only return air I could find to the office ventilation system is located in the training room. Normal returns tend to draw from all work areas to ensure adequate air mix and movement.

Figure 3: Picture showing return vent in training room

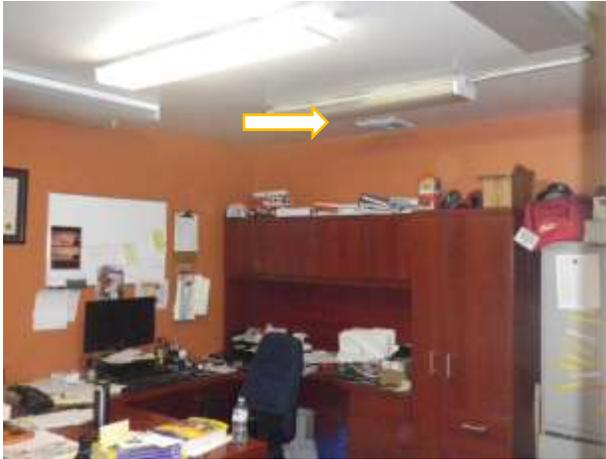
doors when the door is kept closed. Low volumes in the fire chief's room would result in increased CO₂ levels. It was noted that the makeup air vents were dirty which indicates accumulation of dust and dirt in the ventilation system. Periodic cleaning of the system will help minimize this.

Figure 4: Assistant fire chief office. Note make-up air vent

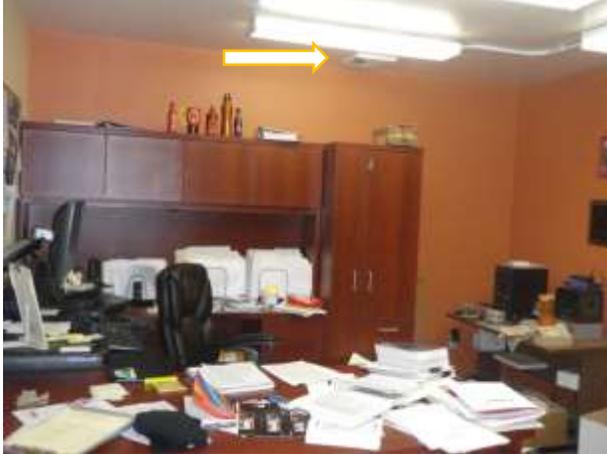
Figure 5: Fire chief's office. Note make-up air vent.

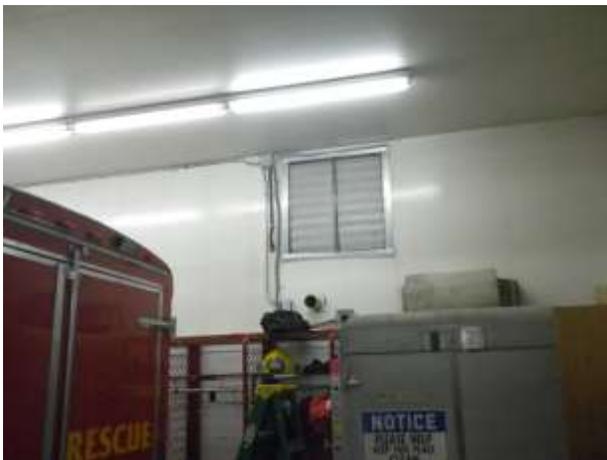
Under the make-up air supply is the fire hose dryer unit. There is a potential for contaminant release during this process which would result in release into the truck bay space. Venting to the outside should be confirmed.

Figure 6: Make up supply fan for truck bay. Note fire hose dryer under fan.

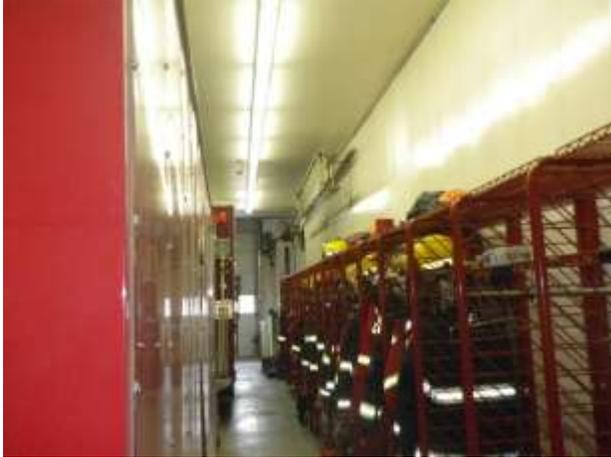
Turnout gear storage: All turnout gear is stored in the truck bays. Any emissions from truck operations can adhere on this safety equipment. Any contaminants on turnout gear can off gas. There are guidelines from NFPA that recommend a dedicated vented room for this equipment.

Figure 7: Picture of turnout gear storage in truck bay east side

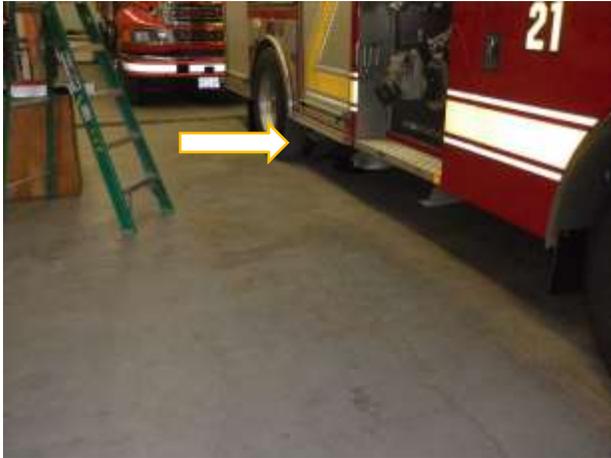
Figure 8: Picture showing exhaust location on truck

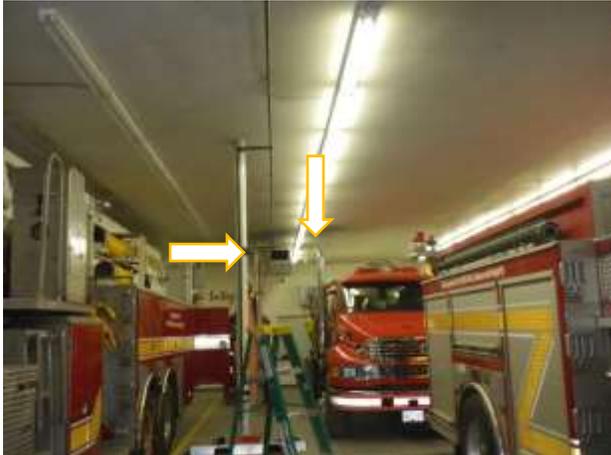
Figure 9: Picture showing vertical exhaust stack and tempered furnace vent

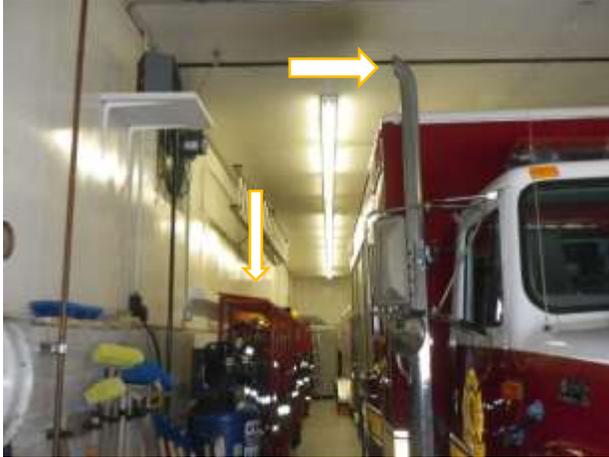
Figure 10: Picture showing turnout gear storage and vertical exhaust stack

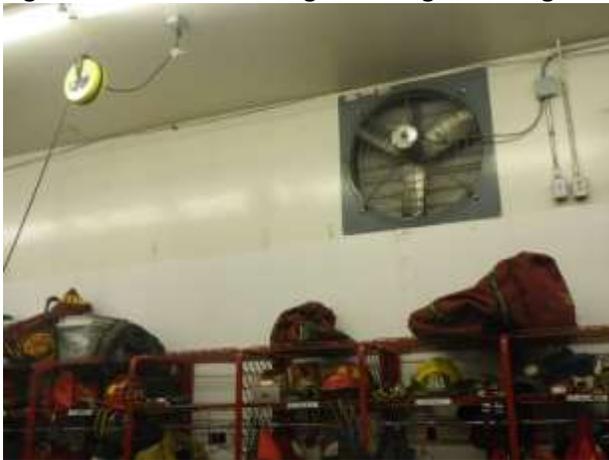
The truck bay has two exhaust wall fans in the truck bay located at the north wall west side and in the south wall east side. Combined these fans exhaust at a rate of approximately 9250 cfm. The make-up air fan supplies the bay with approximately 10,200 cfm of supply air directly from the outside. It is located on the north wall east side. The prevailing winds tend to come from west to east. The supply is slightly pressurizing the space prior to the doors opening. This will enhance the migration of contaminants into the office working area. For this type of ventilation system it is better to have the room under slight negative pressure.

Figure 11: Picture of North wall west exhaust fan

To be effective, the exhaust fans should be located on one wall with supply air entering from the opposite wall. This will increase laminar movement of air towards the exhaust fans. Better design would have tempered makeup air entering at distributed spaces from the opposite walls. Smoke tube and ventilation checks were taken while the fans were operational to assess air flow throughout the space. This was done with all vehicles in the bays with bay doors closed and with several bay doors open. Airflows were quite varied anywhere from no air movement to ~40 fpm. With doors opened airflow nearer the doors increased. Smoke tube assessments confirmed that there were various dead zone throughout the space. Airflow measurements should also be performed when the service trucks have left.

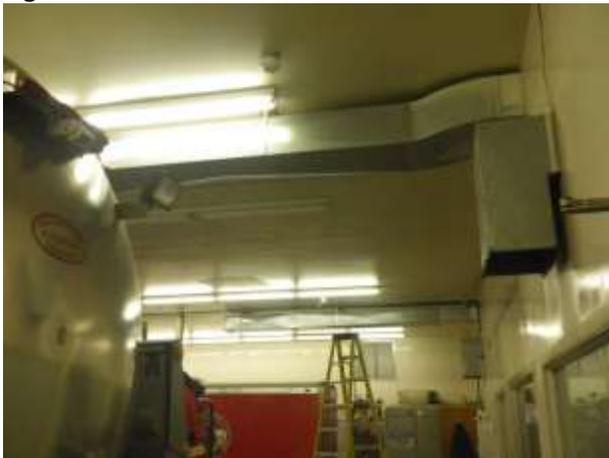
Tempered makeup air: In the truck bays there are two furnaces located in the mezzanine that recirculate truck bay air to maintain temperature in this space. This is not ideal. Tempered make-up air should come directly from the make-up air supply. Secondly, recirculating this air through the furnace has the potential for leakage up in the mezzanine area which is directly above the office working area.

Figure 12: Picture of furnace vents in truck bay recirculating air for heating

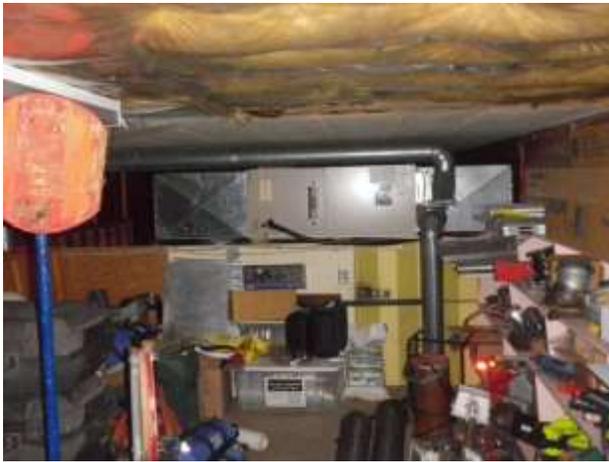
The Lennox unit was observed to be set on temperature demand mode. This mode only allows air to be circulated when the temperature is below a prescribed temperature level. When the temperature is met, no air movement occurs. This would be in contravention of proper ventilation requirements for good indoor air quality. The fans should be operated in continuous mode.

The existing make up air and return to the Lennox is not well balanced. From an initial review of the space there appears to be only one return to the Lennox unit. Measurements indicate air return at 964 cfm. Supply air into the training room was measured at 554 cfm. There were only two other supply vents found in the office working area which were in the fire chief's office and the deputy fire chief's office. Combined the supply to the office working area is ~650 cfm. The difference would place the space under slight negative pressure which will increase the migration of contaminants into this area. Preference is to maintain a slight positive pressure to mitigate the ingress of contaminants from the truck bay.

Figure 14: Picture of Lennox office unit.

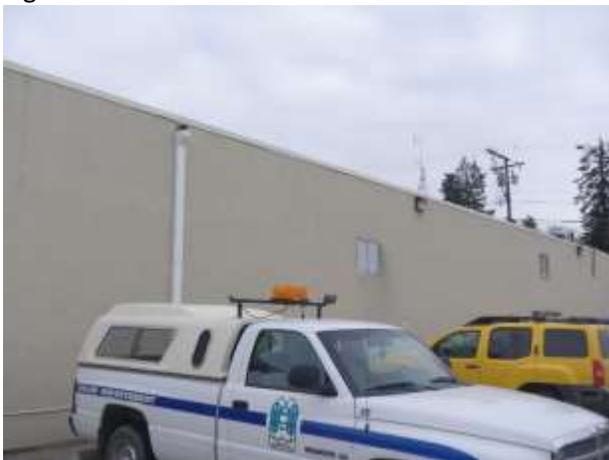
Figure 15: South wall exhaust fan

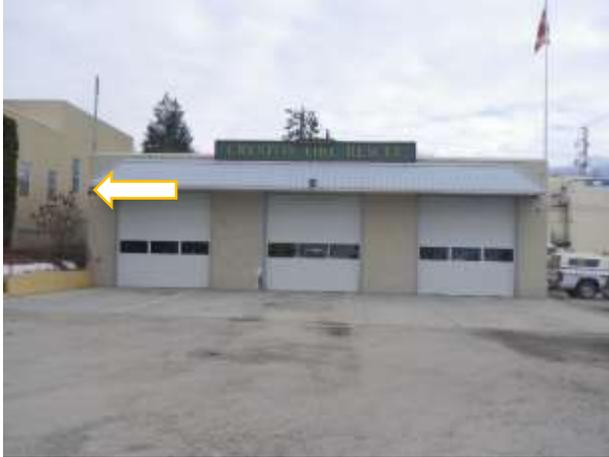
There is a building on the north side of the fire hall which is at a higher elevation to the fire hall. As one moves towards the east side of the building, there is a raised parking lot with a retaining wall approximately 1 metre from the fire hall's north wall at the same height up to the roof of the fire hall. With prevailing winds moving from west to east any contaminants exhausted from the NW exhaust fan has the potential to be entrained back into the fire hall truck bay by the supply exhaust fan since there is a restricted space which would tend to direct air down this narrow space where the supply fan is located. Preference is to capture contaminants at the source versus general capture. The use of breakaway local exhaust ventilation systems should be considered along with general exhaust ventilation.

Figure 16: Front of fire hall. Note raised adjacent building

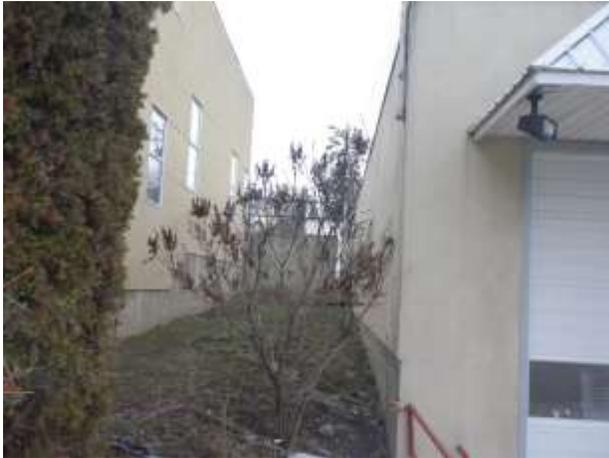
Figure 17: Narrow space between north wall of fire hall and adjacent building

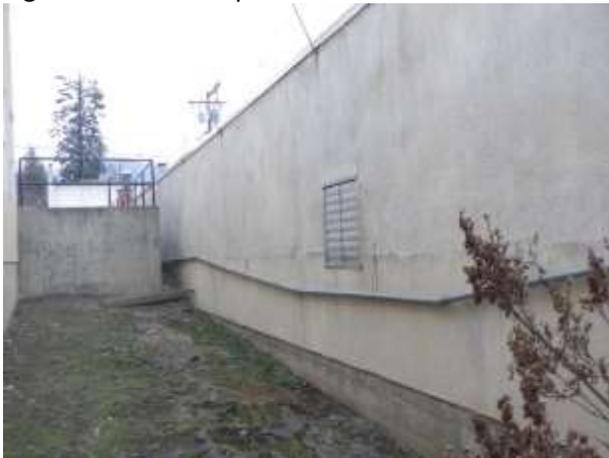
Figure 18: Picture of NW exhaust fan showing narrow space to next building

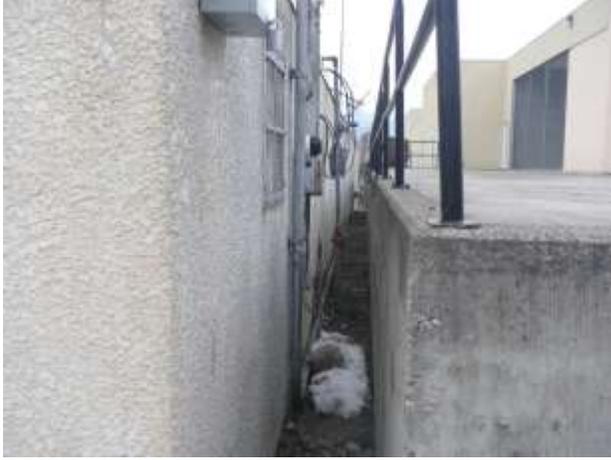
Figure 19: Picture showing narrow space and supply vent on north wall
